ADDENDUM 2

DATE: February 22, 2017
PROJECT: JLL Roof Replacement and Waterproofing Project
RFP NO: 744-R1712
OWNER: The University of Texas Health Science Center at Houston
TO: Prospective Proposers

**UNIVERSITY OF TEXAS HEALTH SCIENCE CENTER
JESSE JONES LIBRARY
ROOF REPLACEMENT AND EXTEIOR WALL REPAIRS/RESTORATION
1133 JOHN FREEMAN BOULEVARD
HOUSTON, TEXAS**

**ADDENDUM NO. 1
FEBRUARY 17, 2017**

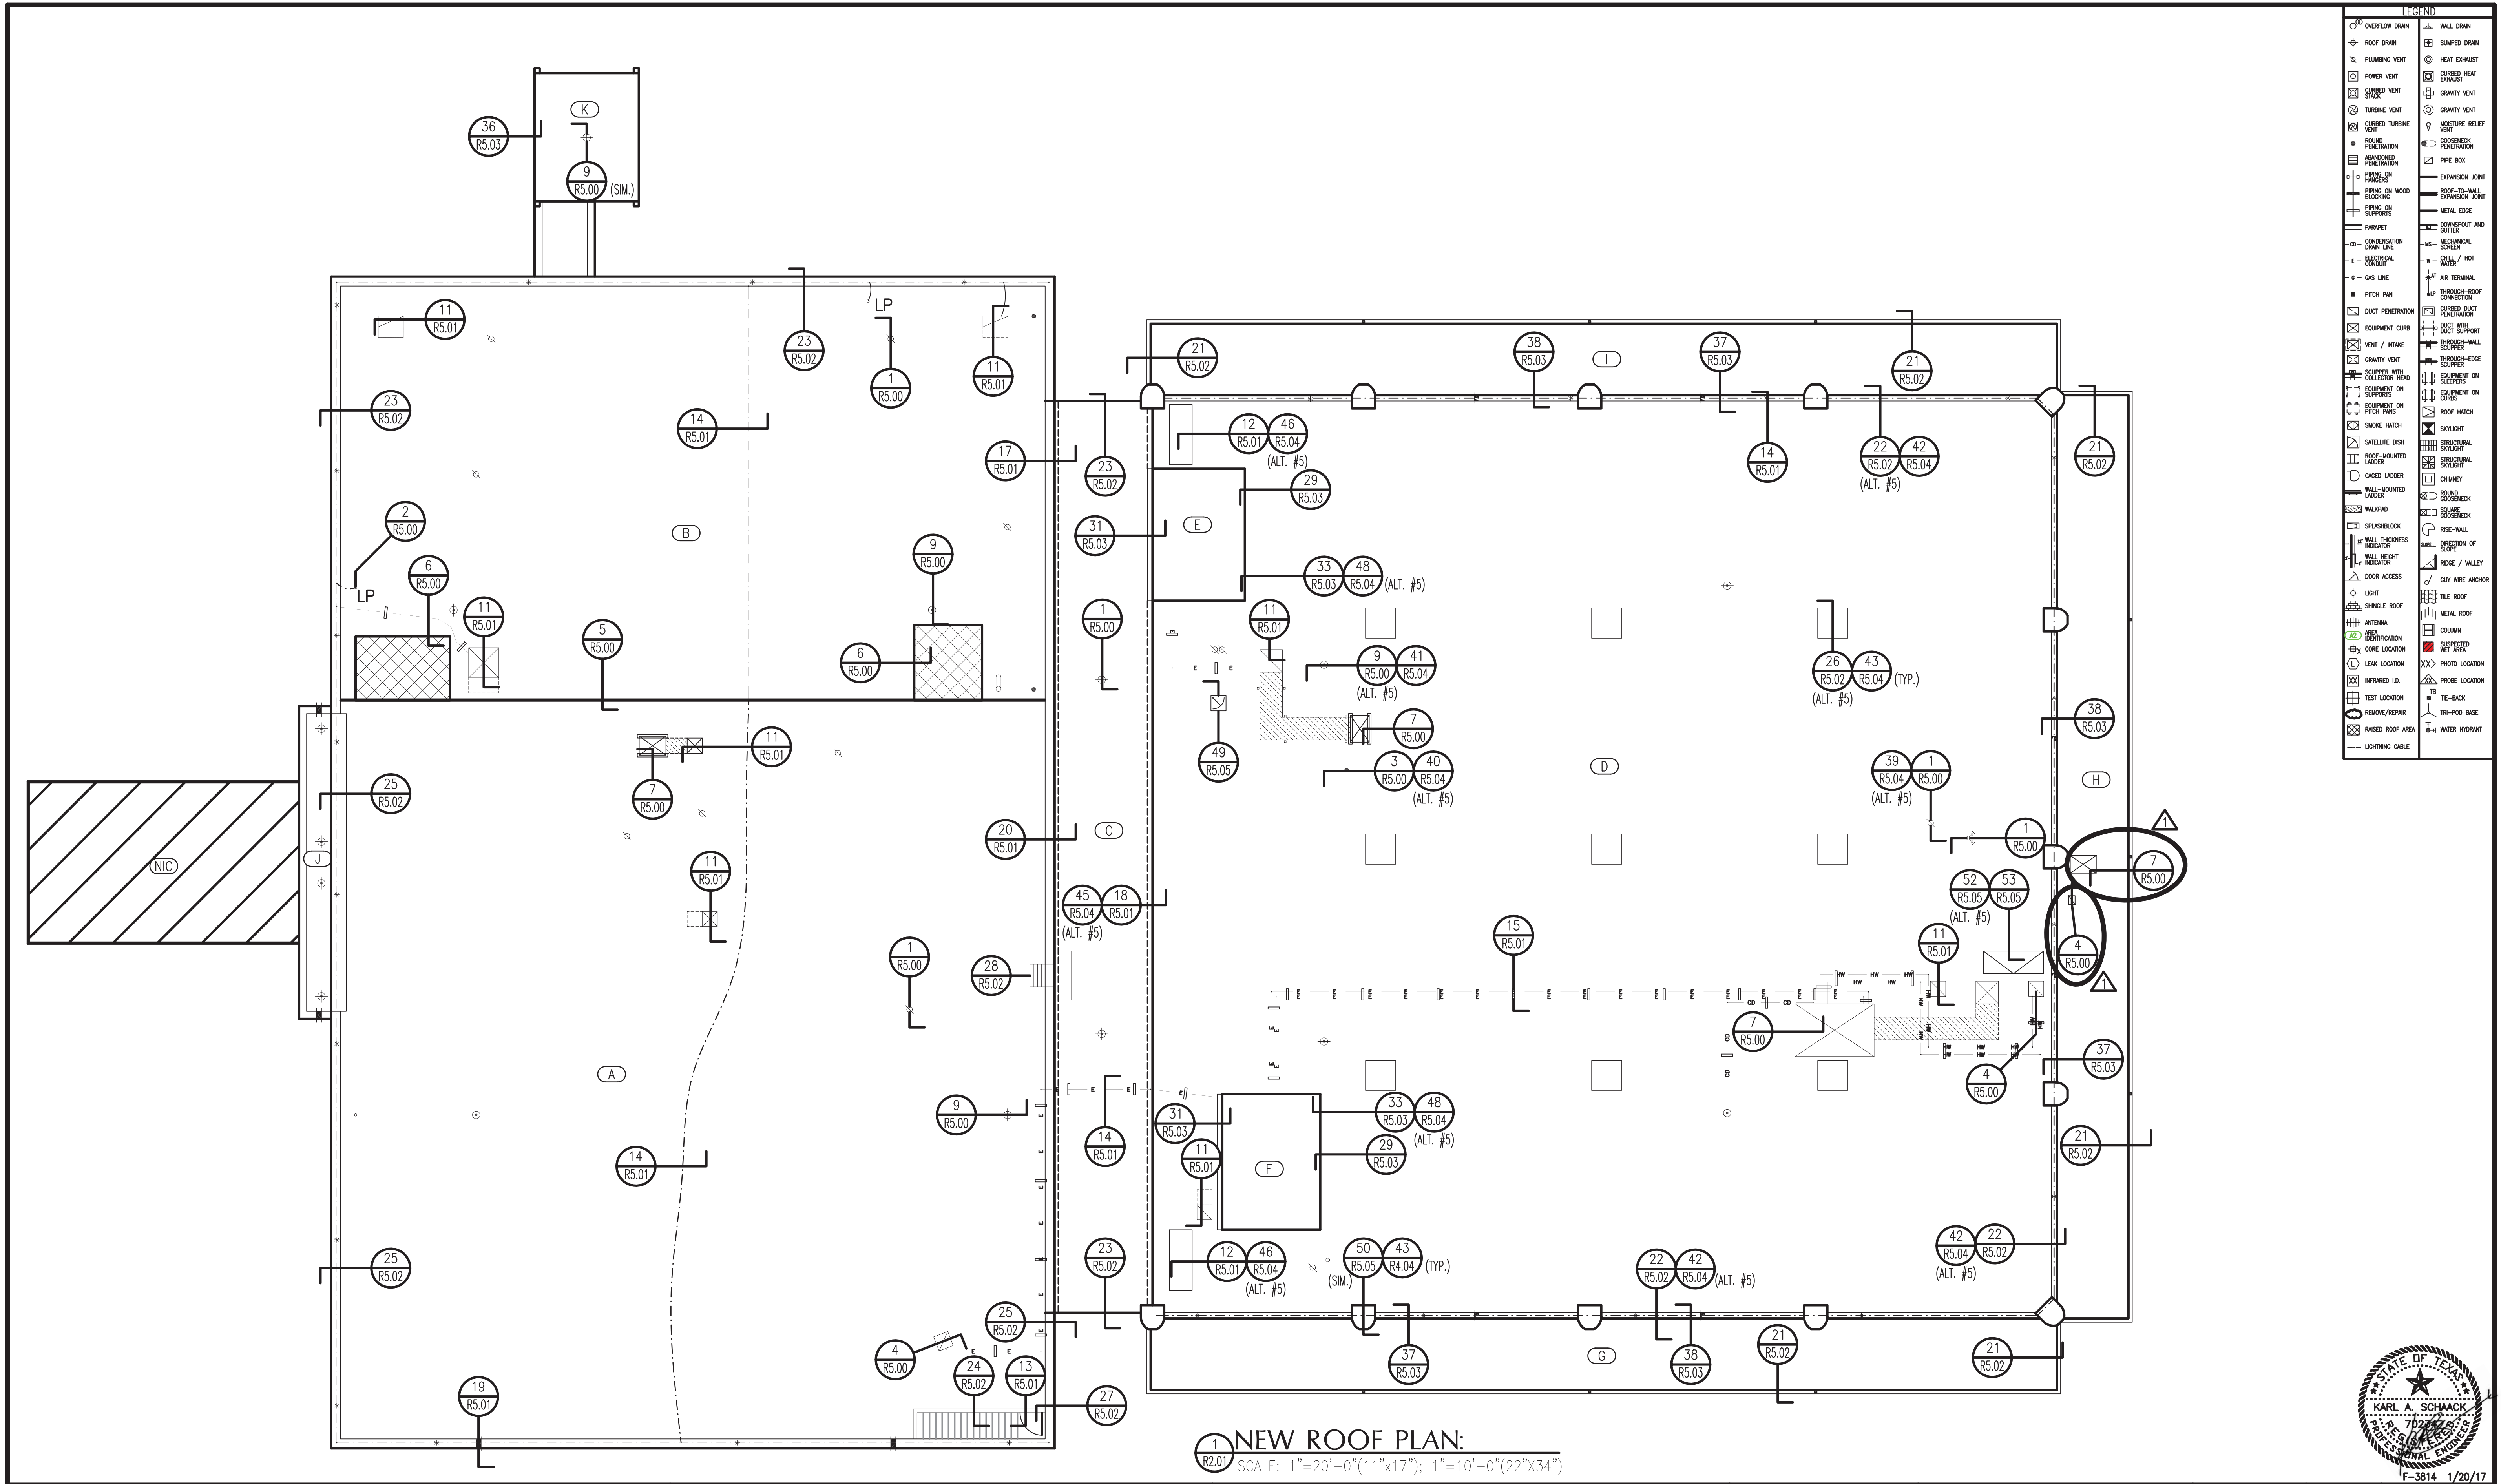
1 NEW ROOF PLAN:
 R2.01 SCALE: 1"=20'-0" (11"x17"); 1"=10'-0" (22"x34")

6. Sheet R2.01 – New Roof Plan: Add illustration and detail designations of equipment curb and pipe box penetration on roof Area “H”. Reference attached revised Sheet R2.01.

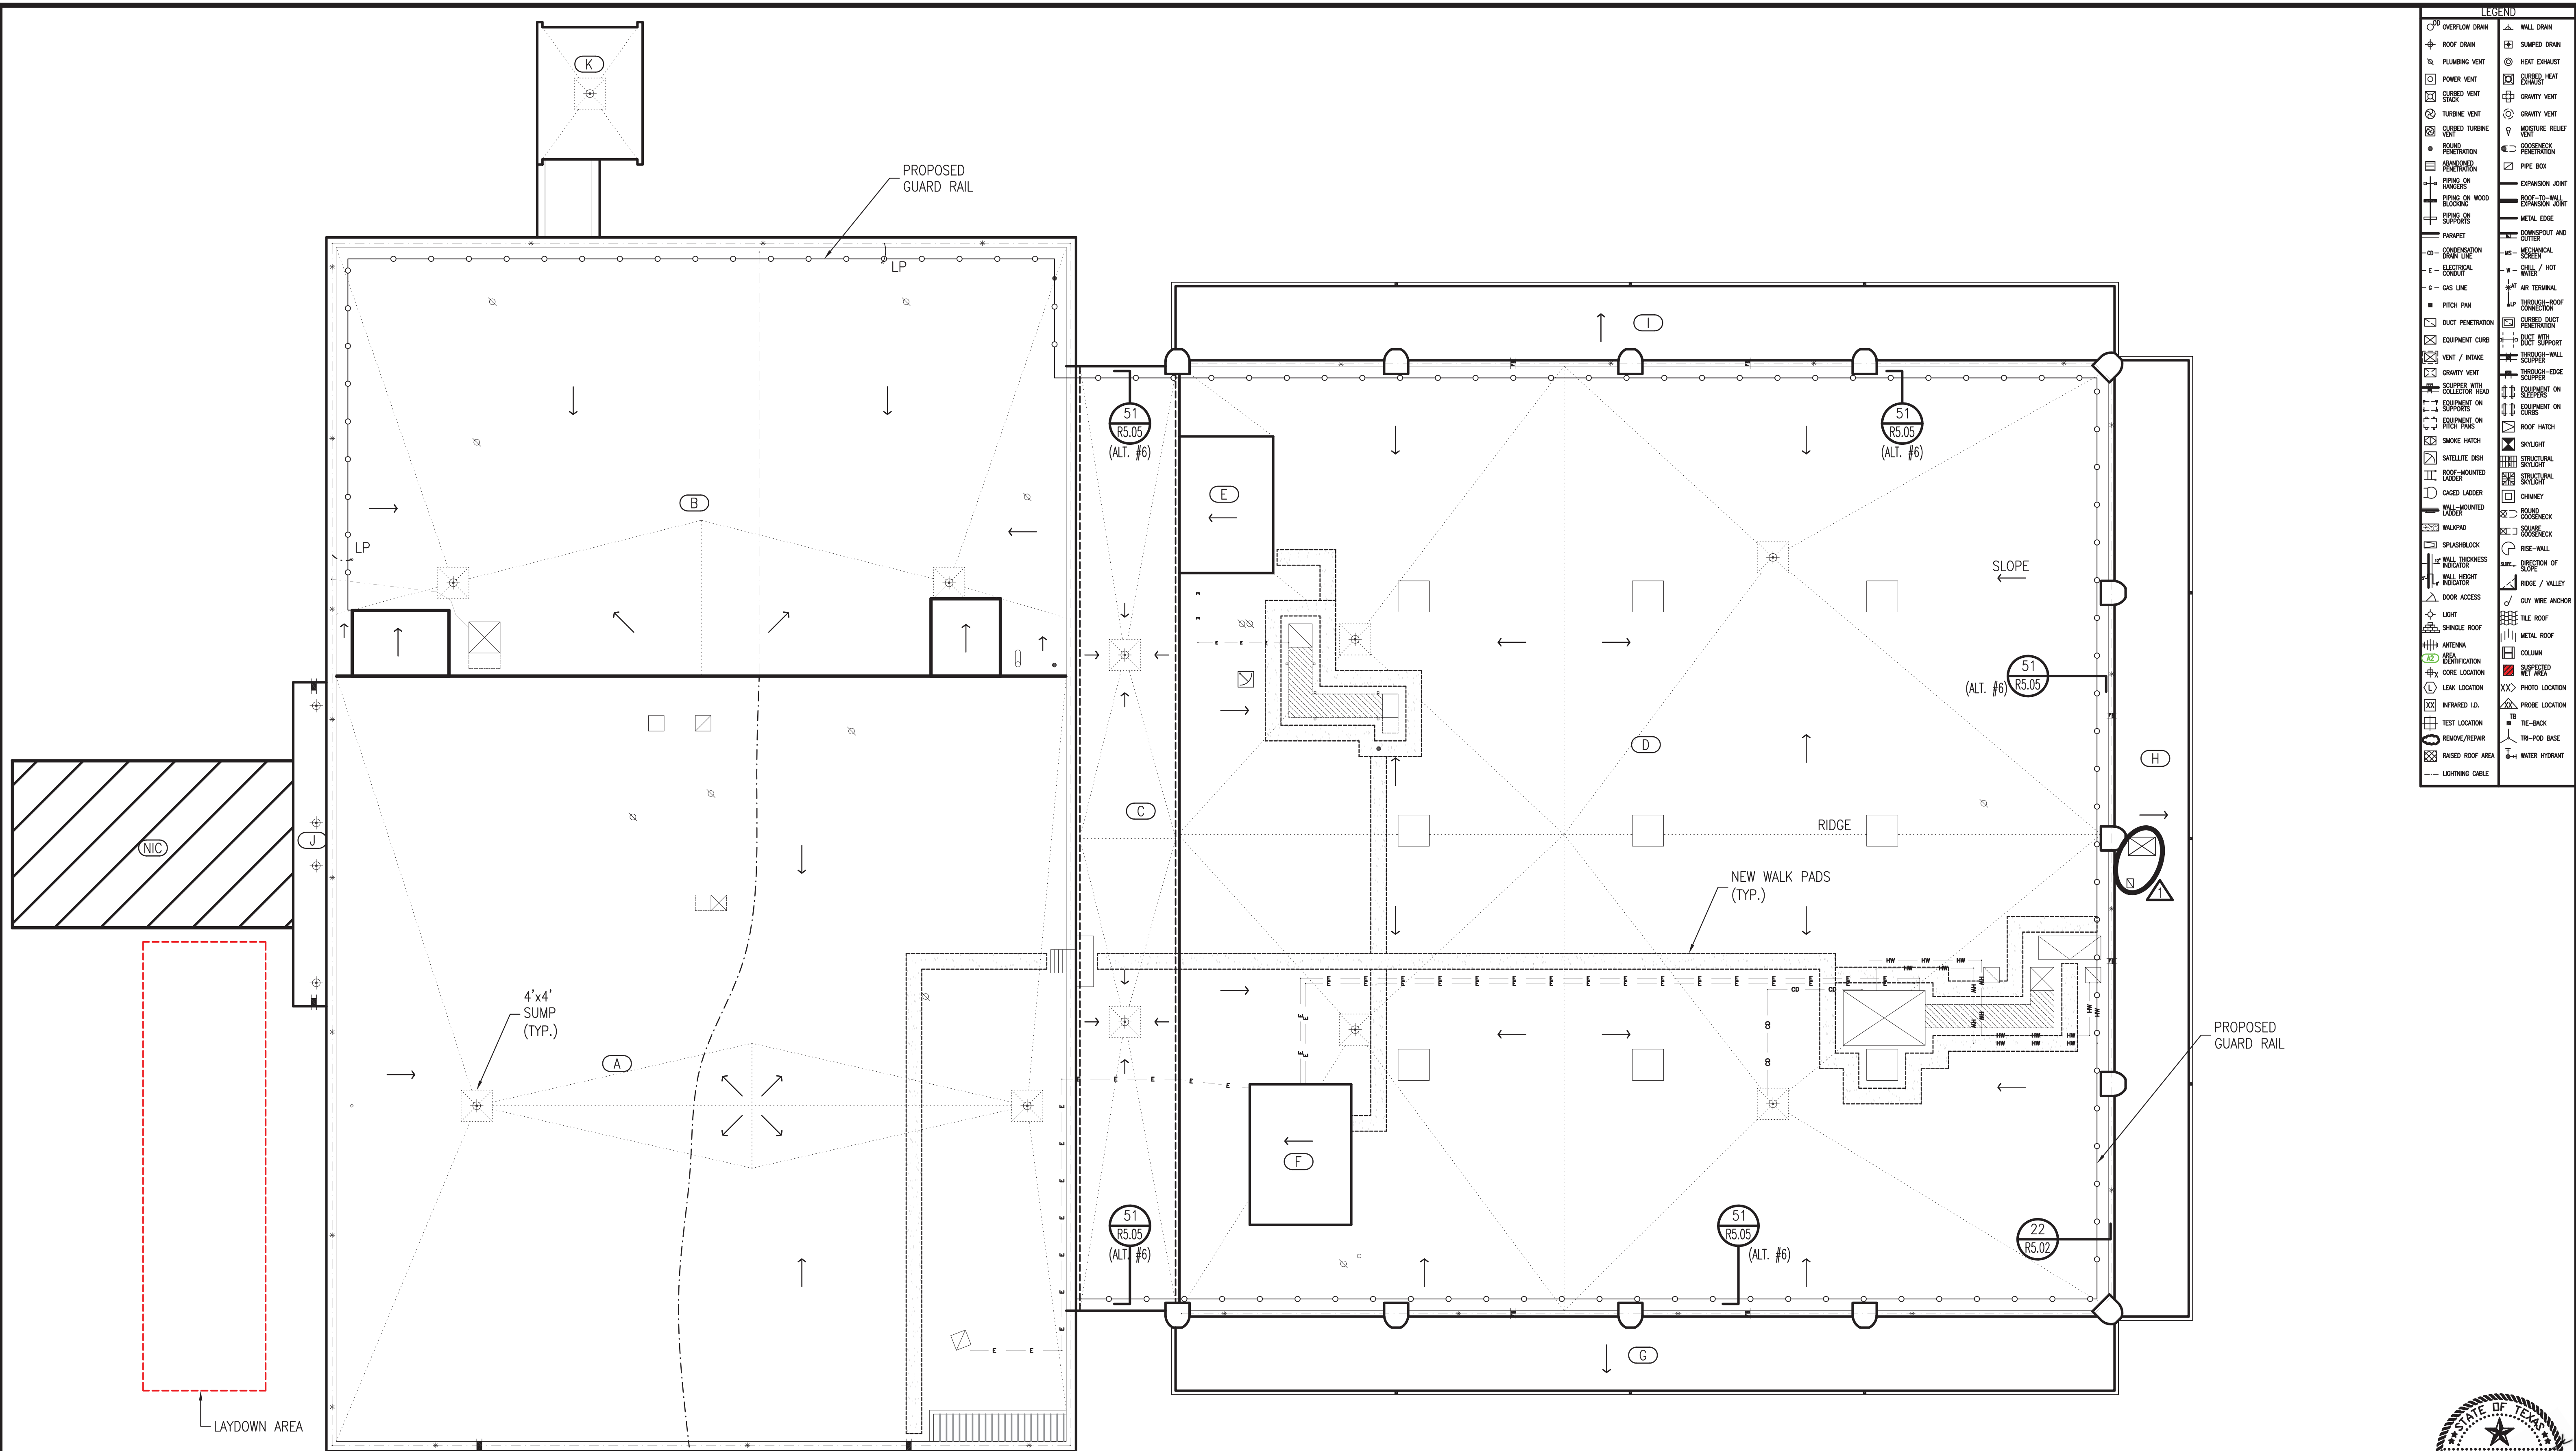
1 ROOF TAPERED/SLOPE, WALK-PAD LAYOUT, LAY-DOWN AREAS, GUARD RAIL, PROPOSED GUARDRAIL AND ROOF ACCESS PLAN:
 SCALE: 1"=20'-0"(11"x17"); 1"=10'-0"(22"x34")

7. Sheet R2.02 – Roof Layout Plan: Add illustration of equipment curb and pipe box penetration on roof Area “H”. Reference attached revised Sheet R2.02.

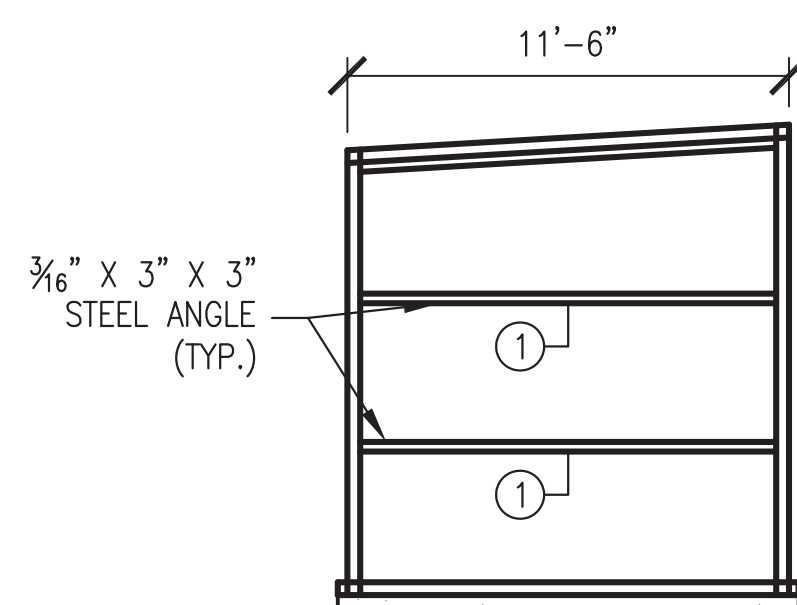
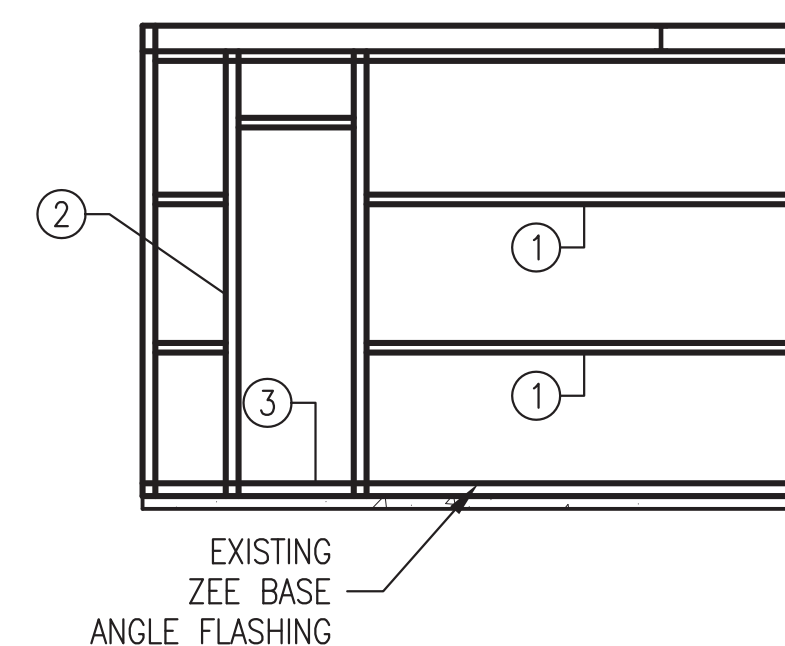
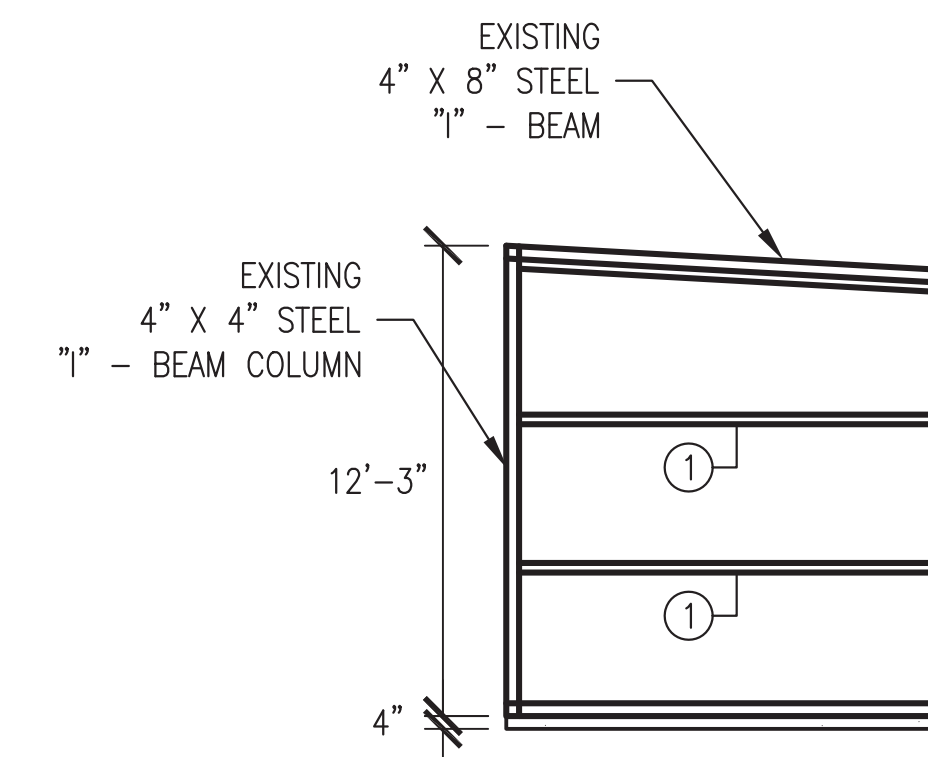
10. Sheet R3.05 – Structural Elevations: Penthouse General Notes: Change Repair Note “1” to read as follows; “Add 10 gauge Zee furring support to penthouse structures”; Add Repair Note “4” – “Move existing electrical boxes, conduit, and other equipment as necessary”. Reference attached revised Sheet R3.05.

- ① ADD 10 GAUGE ZEE FURRING SUPPORT TO PENTHOUSE STRUCTURES.
- ② MODIFY EXISTING HEIGHT AT DOOR LOCATIONS.
- ③ INSTALL CONCRETE CURB BENEATH DOORS.
- ④ MOVE ELECTRICAL BOXES AND CONDUIT IN AS NECESSARY.

Q. Penthouse Relocation:
 1. Relocate and secure electrical boxes, panels, conduit, and other items as necessary to install Zee furring structure to interior of penthouse walls.

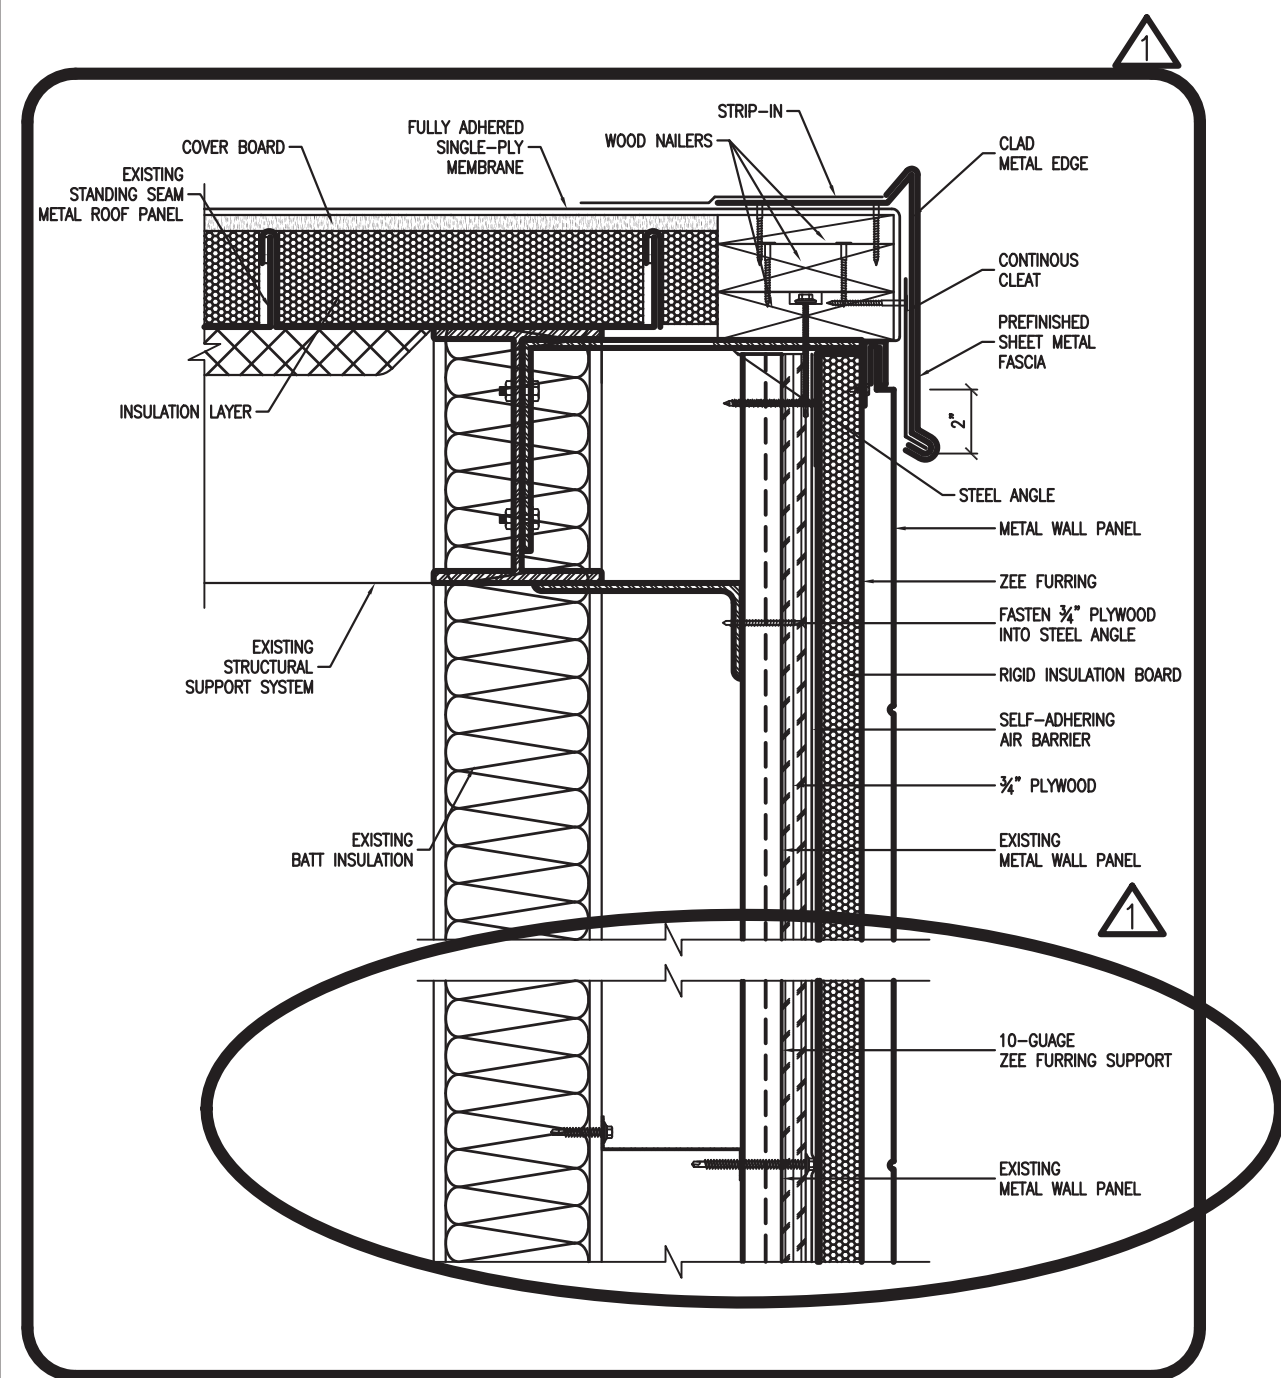
29 METAL RAKE EDGE AT PENTHOUSE
 R5.03 SCALE: NOT TO SCALE

11. Sheet R5.03: Details 29/R5.03 and 31/R5.03: Revise details to illustrate space between existing structural steel and inside surface of existing metal panels; Revise details to illustrate intermediate horizontal Zee furring. Reference attached revised Sheet R5.03.

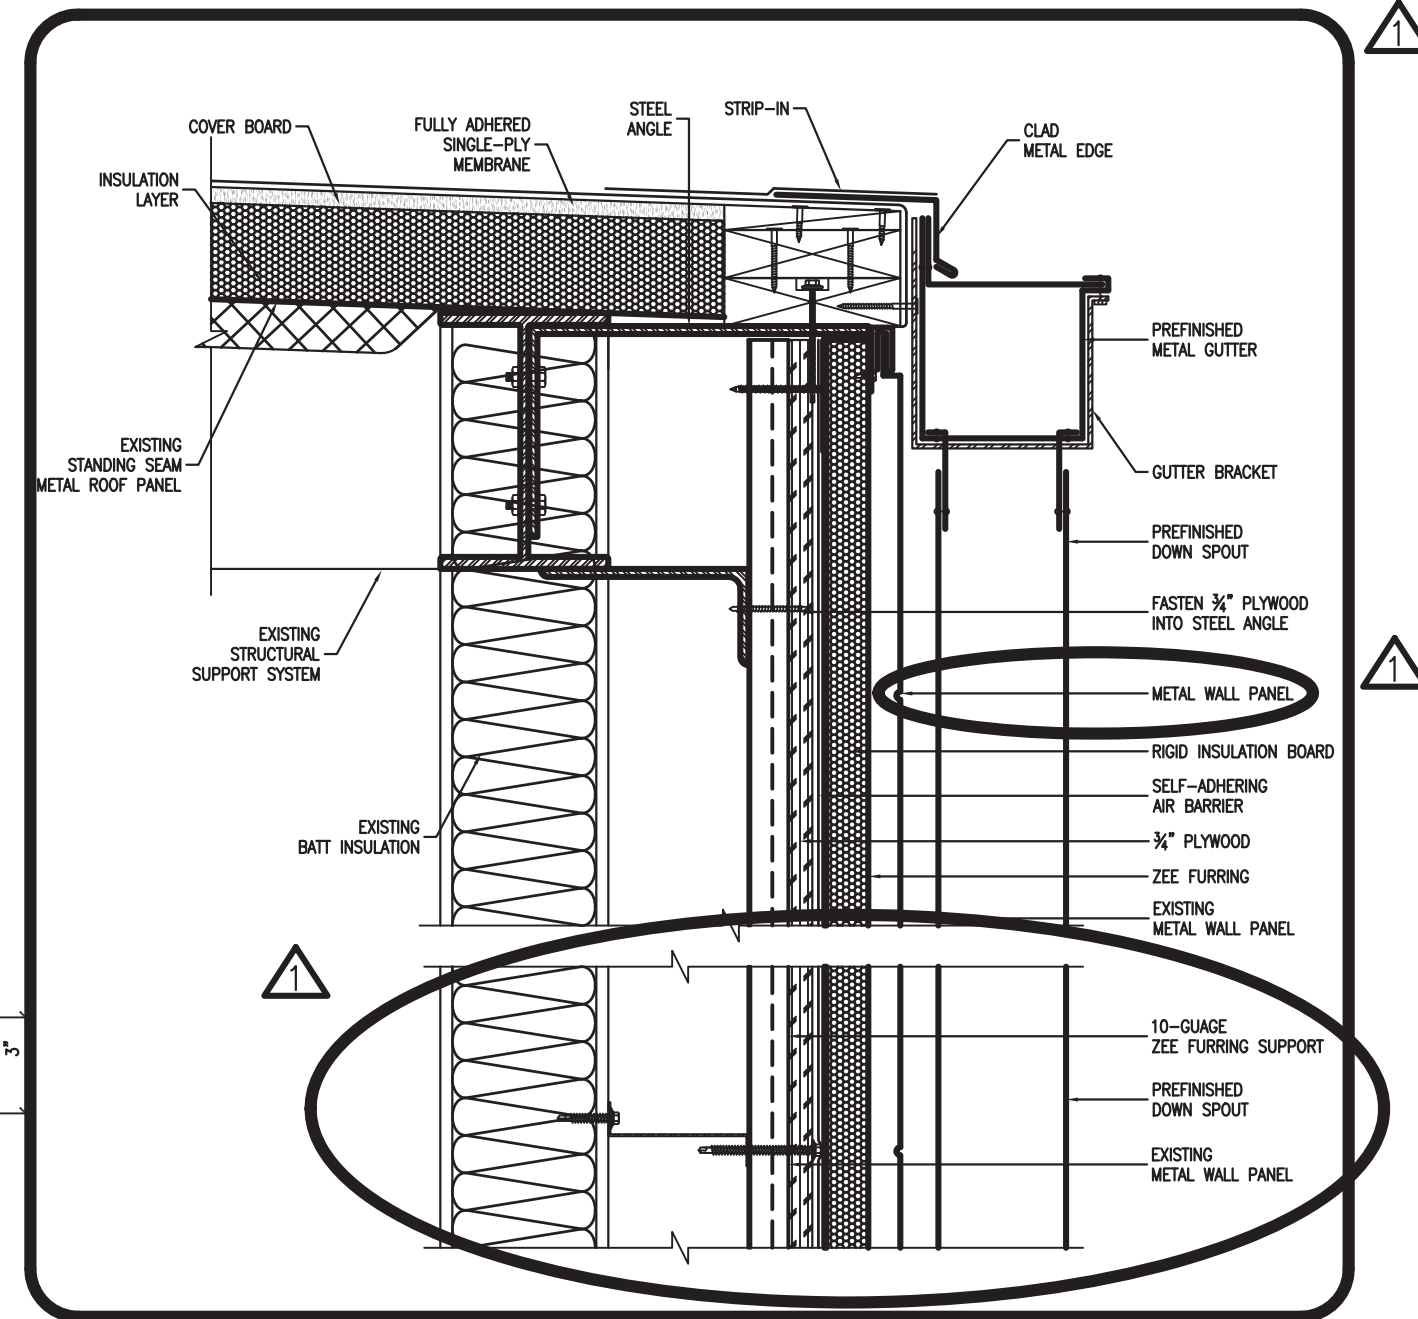
31 METAL EDGE W/GUTTER AT PENTHOUSE
 R5.03 SCALE: NOT TO SCALE

12. Sheet R5.03: Details 31/R5.03: Revise detail note to eliminate word “existing” at exterior metal wall panel. Reference attached revised Sheet R5.03.
